## An Interdisciplinary Approach For Investigating an Accident Originating From Leakage In A Gasketed Bolted Joint

We investigate an accident originating from a leak of hydrochloric acid through a gasketed bolted joint of a measuring equipment operating in a Waste Water Treatment System (WWTS). In spite of the simplicity of the failed component and of the fact that the WWTS is not classified as safety critical, the investigation requires corroborating the traditional techniques of risk analysis such as FMECA, Bow-Tie, etc., with non-standard, interdisciplinary techniques such as structural reliability and task analysis. Moreover, the identification of safety barriers for risk reduction requires applying refined modeling approaches, such as atmospheric dispersion modeling and human reliability modeling.

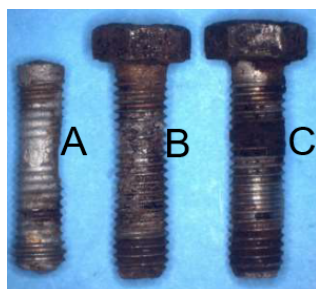
Fig. 1.: Analyzed screws

The failed component was a Commercial Off-The-Shelf (COTS) six screw GBJ. From its visual analysis, it appeared evident that the loss of tightening was due to the failure of a screw, found without the head. This is shown in Figure 1 together with its two nearest screws. Then, the following analyses were performed to get insights about the occurred failure:

- Screw A (Figure 1): found without the head, it had a three-zone fracture:
  - (i) The crack was triggered by a strong deformation and/or incipient break under the head, caused by a twisting moment; in fact, this screw was slightly longer and a little stricter than the other two, due to the resulting plastic deformation.

- (ii) The incipient rupture initially propagated with a morphology of mixed fracture (i.e., mechanical and stress corrosion cracking).
  - (iii) The final part of the fracture was characterized by stress corrosion cracking.

- Screw B (Figure 1): although it looked intact at a first visual inspection, it actually had a torsional fracture under-head (helical progression) and stress-cracking in all the positions that have undergone a cold work hardening. Screw B was longer than screw C, but shorter

than screw A. Also this screw had the thread strongly damaged by the leakage of the acid at the same distance from the head as in screw A.

- Screw C (Figure 1): this was undeformed, with stress corrosion cracking affecting a small area.

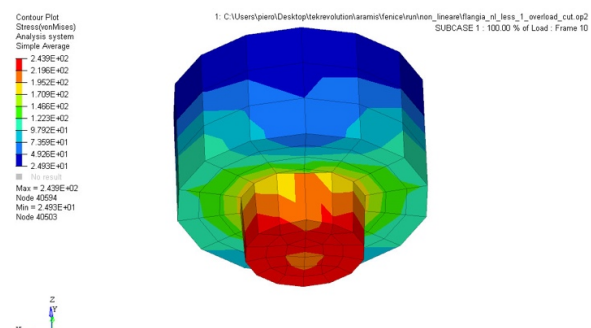
- Tightening sequence is critical for joint reliability: wrong sequences entail asymmetrical bolt preloads and, thus, different stress conditions. In particular, the most stressed part is the screw underhead (Figure 3), where microcracks can originate.
- Interstitial corrosion: the water trapped under the head (e.g., due to humidity) will run out of oxygen, which migrates towards the metal while not replenished. The water, then, becomes acidic and the crack under the head (originated by the mechanism described in the previous bullet) becomes more anodic than in the adjacent regions, with consequent corrosion (Figure 4).

Fig. 3.: Effect of asymmetrical preload: Von Mises stress on screw stem with constant preload on 5 screws of 8kN, preload on screw 6 of 10kN

- Credible values of loads on the bolts are between 8kN and 12kN, as also it results from a comparison with technical datasheets and experience.
- FEM analysis with non-linear materials showed that the asymmetry of the loads brings the screws into a stressful condition in the underhead area, consistently with what emerged from DMEA.
- Given the characteristics of the tank, we can assume that leakage cannot occur when the pressure minimum value on the gasket is larger than 0.5 MPa.
- The total loss of tightening of a single bolt is not sufficient to have a leakage; this requires also a significant relaxation of at least one of the adjacent bolts.

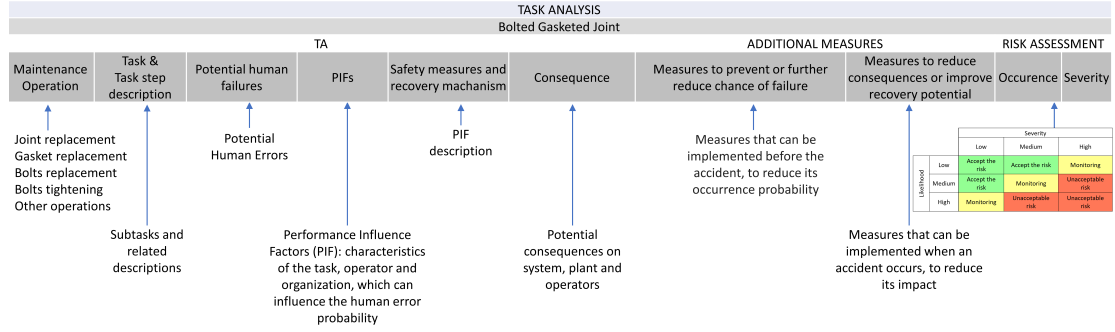
The outcomes of the TA confirmed that asymmetries may be introduced in the loads on the

GBJ screws during reassembly of the joint and verification of the closing load. In fact, these tasks were not performed based on detailed procedures and with proper tools (e.g., torque wrench); rather, the operators were used to maintain the GBJ upon routine inspections, based on their experience. Maintenance actions on GBJ were neither tracked in maintenance reports, as GBJ was classified as not critical.

Fig. 5.: Worksheet for TA

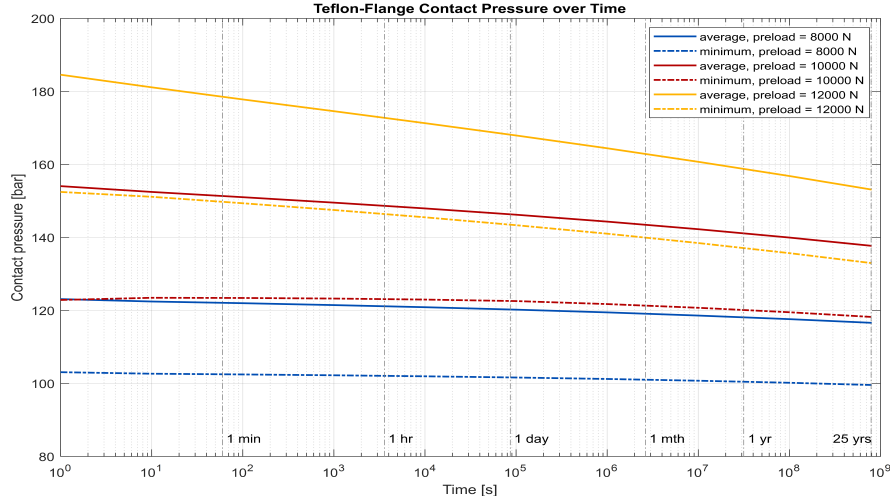
Figure 6 shows the average and minimum values over a time horizon of 25 years of the pressure on the teflon gasket for three different values of nominal preload (i.e., 8, 10 and 12 kN), equal for all six screws. The minimum pressure values always remain much higher than the threshold to have a leakage (i.e., 0.5 MPa). This means that the accident cause could not be just the creep phenomenon: if the GBJ bolt preloads had been correctly set and the GBJ properly operated, the leakage would not have occurred.

Fig. 6.: Pressure on the gasket

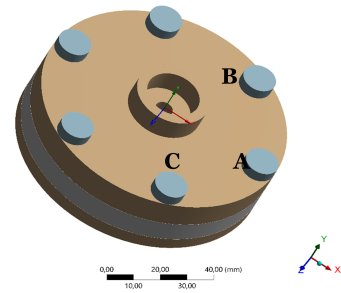
cracking can describe the crack propagation in case of small amplitudes of both thermal cycles and vibration and also small values of the GBJ internal pressure. Therefore, we used the FEM model to investigate whether and how the asymmetrical relaxation of the bolts due to creep can cause this phenomenon. Namely, with reference to Figure 7, we set to 15 kN the preload values on screws A and B, as this is large enough to generate the torsional overload damage underneath and the significant plastic deformation identified by the preliminary analysis, and to 10 kN the preload on the remaining screws. An initial crack underneath was set on screw A.

Fig. 7.: Screws A, B and C

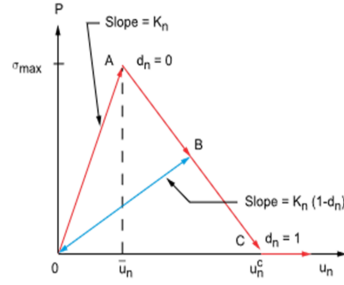
Fig. 8.: Corrosion-crack model

In words, once the maximum allowable stress,  $\sigma_{max}$ , is reached, the rigidity of the material progressively decreases until the complete detachment of the two surfaces ( $u_n^c$ ). The area underlying the arrows in Figure 8 indicates the critical fracture energy, which was set to  $G_{cn} = 1.2 \cdot 10^5$ . The FEM model showed that the progressive relaxation of screws B and C causes a corresponding increase in the load on screw A, which entails the gradual propagation of the crack underneath, given the stress concentration in the discontinuity area of the crack front. In the occurred accident, this phenomenon was accelerated by chloride stress corrosion cracking due to possible minimal leakages of hydrochloric acid vapors, gradually reducing the resistant section of the screw in a self-sustaining process that finally leads to the relatively sudden cut of the screw head and to consequent loss of seal of the flange.

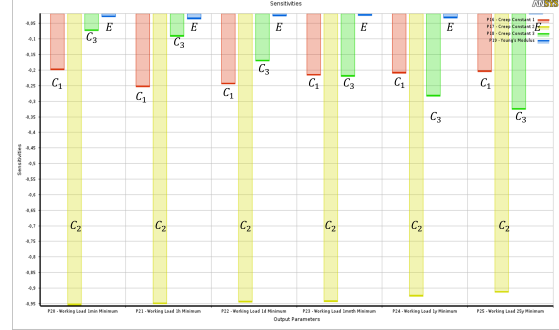
To find the probability of leakage over time, consider the epistemic uncertainty on the model parameters (Table 3) and apply the Monte Carlo method for its propagation through the FEM model. To reduce the computational burden sensitivity analysis was first carried out for creep model, to identify the parameters that contribute most to the creep evolution. Figure 9 summarizes the results:  $C_2$  has the greatest impact on the tightening force over the entire time horizon.

Fig. 9.: Sensitivity analysis: results relevant to different time instants

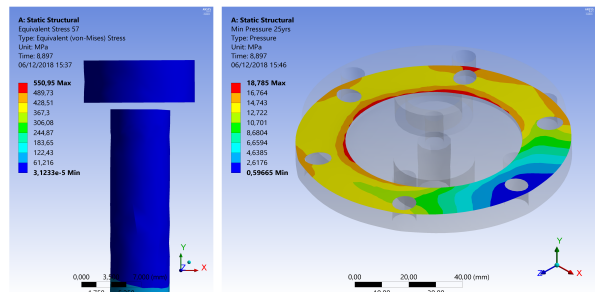
The study showed that considering both degradation mechanisms (stress corrosion and relaxation), the probability of having an acid loss over the 25 years of system operation is in any case less than  $4 \cdot 10^{-3}$  (Figures 10-11).

Fig. 10.: Corrosion-crack model

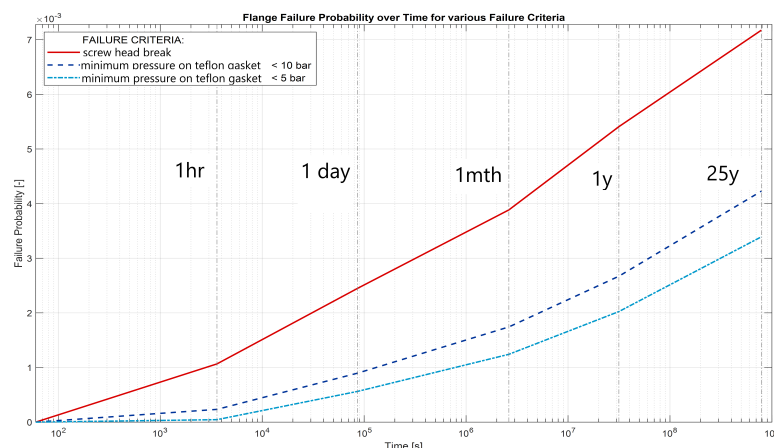
Fig. 11.: Corrosion-crack model
